## **Release Notes for DrayTek Vigor2862 series (UK/Ireland)**

Firmware Version	3.8.8.2_BT (Formal Release)
Release Type	<b>Critical</b> – Upgrade recommended immediately
Build Date	18 <sup>th</sup> May 2018
Release Date	18 <sup>th</sup> May 2018
Revision	73942
Applicable Models	Vigor2862, Vigor2862n, Vigor 2862Ln, Vigor2862ac, Vigor 2862Lac, Vigor 2862Vac
VDSL Modem Code	779517
ADSL Modem Code	773F01
Locale	UK & Ireland Only

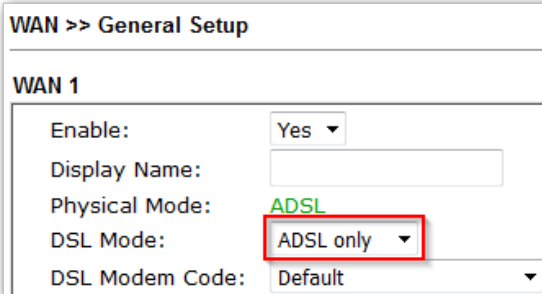
1. If experiencing an issue establishing an Internet connection on ADSL or ADSL2+ connections, set the WAN1 DSL Mode to “ADSL Only”

WAN >> General Setup	
WAN 1	
Enable:	Yes ▼
Display Name:	
Physical Mode:	ADSL
DSL Mode:	ADSL only ▼
DSL Modem Code:	Default ▼
