Release Notes for DrayTek Vigor2862 series (UK/Ireland)

Firmware Version	3.9.9.9 (Formal Release)
Release Type	Regular – Upgrade recommended when convenient
Build Date	24 th February 2025
Release Date	19 th March 2025
Revision	23033_1208_65a0ee8963
Applicable Models	Vigor2862, Vigor2862n, Vigor 2862Ln, Vigor2862ac, Vigor 2862Lac, Vigor 2862Vac
VDSL Modem Code	779517
ADSL Modem Code	773F01
Locale	UK & Ireland Only

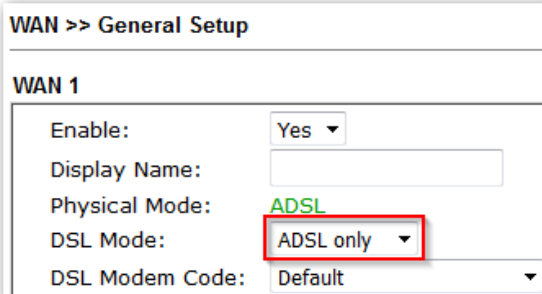
1. If experiencing an issue establishing an Internet connection on ADSL or ADSL2+ connections, set the WAN1 DSL Mode to “ADSL Only”
