Release Notes for DrayTek Vigor2862 series (UK/Ireland)

Firmware Version	3.9.9.12 (Formal Release)
Release Type	Critical – Upgrade recommended immediately
Build Date	12 th August 2025
Release Date	3 rd September 2025
Revision	24253_1223_ff9c7077e4
Applicable Models	Vigor2862, Vigor2862n, Vigor 2862Ln, Vigor2862ac, Vigor 2862Lac, Vigor 2862Vac
VDSL Modem Code	779517
ADSL Modem Code	773F01
Locale	UK & Ireland Only

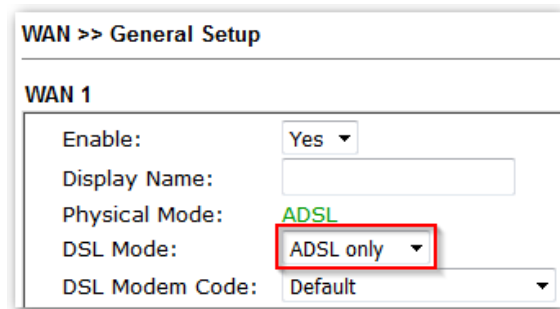
1. If experiencing an issue establishing an Internet connection on ADSL or ADSL2+ connections, set the WAN1 DSL Mode to “ADSL Only”
