## **Release Notes for DrayTek Vigor2862 series (UK/Ireland)**

Firmware Version	3.9.4_BT (Formal Release)
Release Type	<b>Regular</b> – Upgrade recommended when convenient
Build Date	28 <sup>th</sup> May 2020
Release Date	16 <sup>th</sup> June 2020
Revision	90778
Applicable Models	Vigor2862, Vigor2862n, Vigor 2862Ln, Vigor2862ac, Vigor 2862Lac, Vigor 2862Vac
VDSL Modem Code	779517
ADSL Modem Code	773F01
Locale	UK & Ireland Only

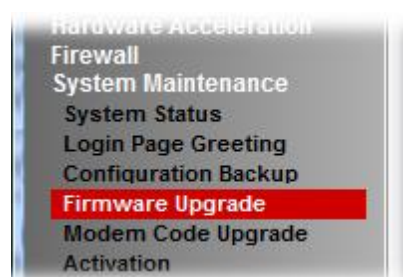
To upgrade firmware, select '*firmware upgrade*' from the router's system maintenance menu and select the correct file. Ensure that you select the ALL file unless you want to wipe out your router's settings back to factory default.
