Release Notes for DrayTek Vigor 2926 series (UK/Ireland)

Firmware Version	3.8.9.1 (Formal Release)
Release Type	Regular – Upgrade recommended when convenient Note: A previous firmware (3.8.8.2) was a critical release . This f/w includes all changes/improvements that were in 3.8.8.2.
Build Date	12 th June 2018
Release Date	9 th July 2018
Revision	74522
Applicable Models	Vigor2926, Vigor2926n, Vigor2926ac
Locale	UK & Ireland Only

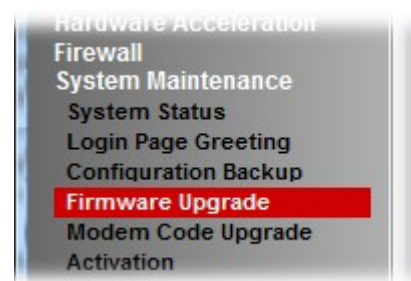
To upgrade firmware, select '*firmware upgrade*' from the router's system maintenance menu and select the correct file. Ensure that you select the ALL file unless you want to wipe out your router's settings back to factory default.
