Release Notes for DrayTek Vigor 2926 series (UK/Ireland)

Firmware Version	3.9.9 (Formal Release)
Release Type	Regular – Upgrade recommended when convenient
Build Date	28 th November 2022
Release Date	19 th December 2022
Revision	16197_1064_5ae179909c
Applicable Models	Vigor2926, Vigor2926n, Vigor2926ac
Locale	UK & Ireland Only

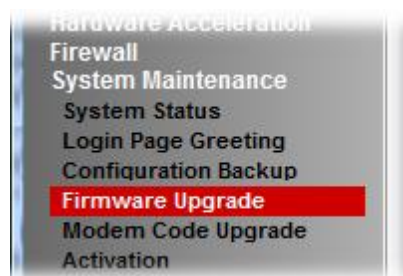
To upgrade firmware, select '*firmware upgrade*' from the router's system maintenance menu and select the correct file. Ensure that you select the ALL file unless you want to wipe out your router's settings back to factory default.
