## **Release Notes for DrayTek Vigor 3220 (UK/Ireland)**

Firmware Version	3.9.1 (Formal Release)
Release Type	<b>Regular</b> – Upgrade recommended when convenient
Build Date	10 <sup>th</sup> June 2019
Release Date	11 <sup>th</sup> July 2019
Revision	82600
Applicable Models	Vigor 3220
Locale	UK Only

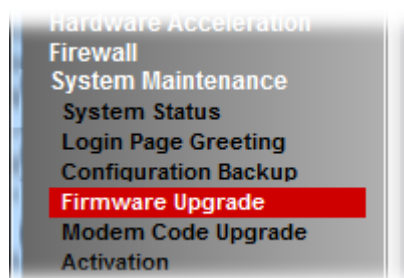
It is recommended that you take a configuration backup prior to upgrading the firmware. This can be done from the router's system maintenance menu.

To upgrade firmware, select '*firmware upgrade*' from the router's system maintenance menu and select the correct file. Ensure that you select the ALL file unless you want to wipe out your router's settings back to factory default.
