## **Release Notes for DrayTek Vigor 3220 (UK/Ireland)**

Firmware Version	3.9.2 (Formal Release)
Release Type	<b>Regular</b> – Upgrade recommended when convenient
Build Date	27 <sup>th</sup> December 2019
Release Date	24 <sup>th</sup> January 2020
Revision	87487
Applicable Models	Vigor 3220
Locale	UK Only

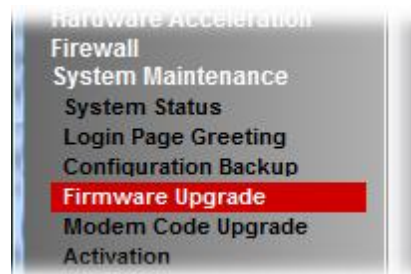
To upgrade firmware, select '*firmware upgrade*' from the router's system maintenance menu and select the correct file. Ensure that you select the ALL file unless you want to wipe out your router's settings back to factory default.
