Release Notes for DrayTek Vigor 3220 (UK/Ireland)

| Firmware Version | 3.9.8.2 (Formal Release) |
| Applicable Models | Vigor 3220 |

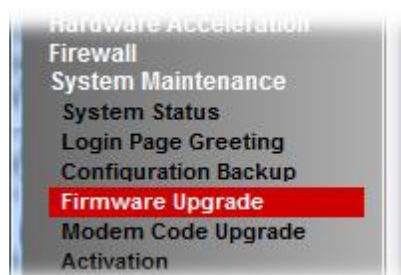
To upgrade firmware, select '*firmware upgrade*' from the router's system maintenance menu and select the correct file. Ensure that you select the ALL file unless you want to wipe out your router's settings back to factory default.
