Release Notes for DrayTek Vigor 3220 (UK/Ireland)

Firmware Version	3.9.8.8 (Formal Release)
Release Type	Critical – Upgrade recommended immediately
Build Date	4 th August 2025
Release Date	9 th September 2025
Revision	24052_1221_4d773b81fd
Applicable Models	Vigor 3220
Locale	UK Only

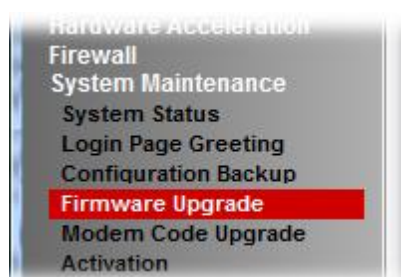
To upgrade firmware, select '*firmware upgrade*' from the router's system maintenance menu and select the correct file. Ensure that you select the ALL file unless you want to wipe out your router's settings back to factory default.
