Release Notes for DrayTek Vigor 3910 (UK/Ireland)

Firmware Version	4.4.3.4 – Mainline branch (Formal Release)
Release Type	Regular – Upgrade recommended when convenient
Build Date	27 th March 2025
Release Date	22 nd May 2025
Revision	4926_7605_b8950f82bc
Applicable Models	Vigor 3910
Locale	UK & Ireland Only

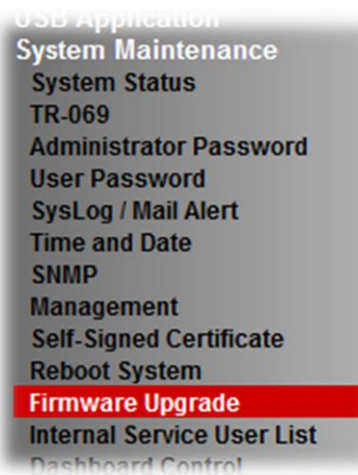
To upgrade firmware, select '*firmware upgrade*' from the router's system maintenance menu and select the correct file. Ensure that you select the ALL file unless you want to wipe out your router's settings back to factory default.
