Release Notes for DrayTek Vigor 3912 (UK/Ireland)

Firmware Version	4.4.5.2 – Mainline branch (Formal Release)
Release Type	Important – Review release notes and upgrade if the changes affect your system stability, performance, or security
Build Date	27 th November 2025
Release Date	19 th December 2025
Revision	5373_8380_4819682160
Applicable Models	Vigor 3912, Vigor 3912S
Locale	UK & Ireland Only

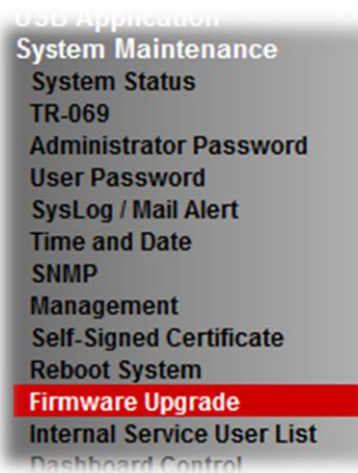
To upgrade firmware, select '*firmware upgrade*' from the router's system maintenance menu and select the correct file. Ensure that you select the SFW file unless you want to wipe out your router's settings back to factory default.
